# Connecticut River Estuary Riparian Sampler

Created for the  
Connecticut River Gateway Commission  
By Tidewater Institute

The pictures contained in this sampler come from the 2006 investigation of Connecticut River estuary riparian buffers undertaken by the Connecticut River Estuary Regional Planning Agency (CRERPA) and Tidewater Institute (TI).

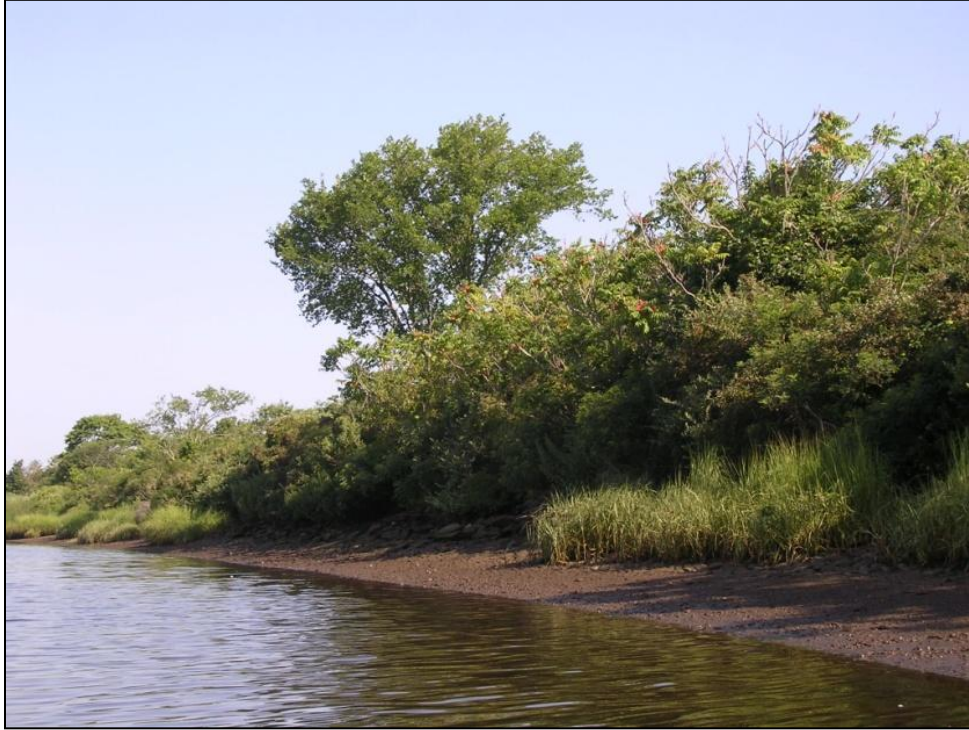
1. This is a healthy, tidal riparian buffer toward the mouth of the Connecticut River. It maintains a diversity of vegetation – trees, shrubs and tidal grasses. This riparian area has species diversity (a good variety of plants) and structural diversity as well.

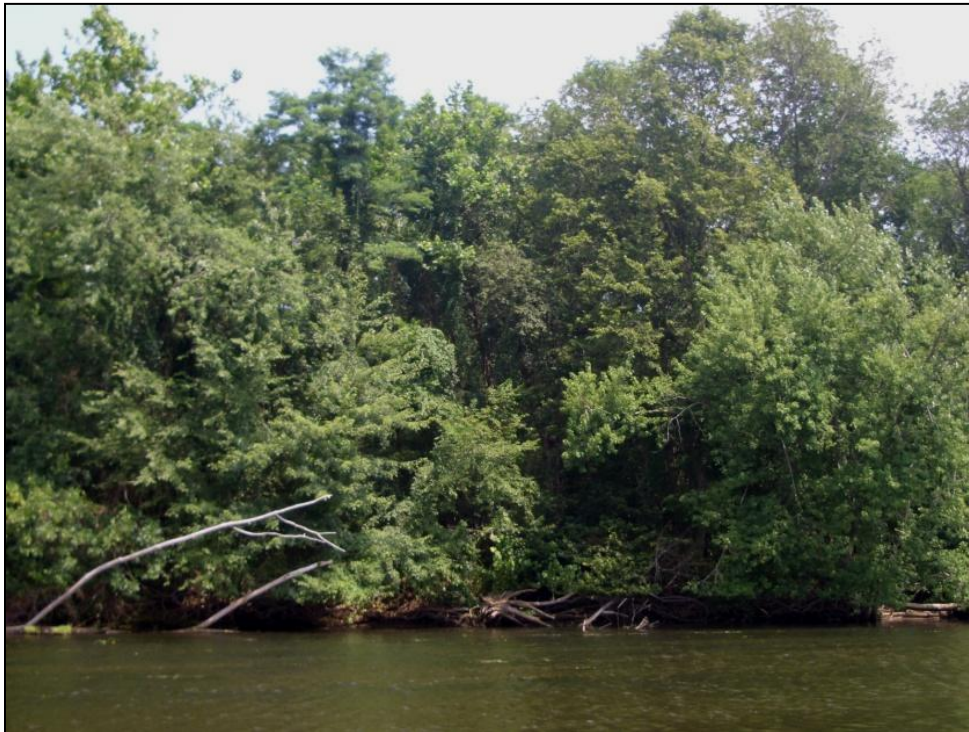
2. This is a fine example of a diverse mid-estuary riparian buffer that contains an abundance of predominantly tree and shrub species. The density of vegetation makes it easy to see why wildlife – particularly breeding and migratory birds – finds refuge in such places along the water's edge.

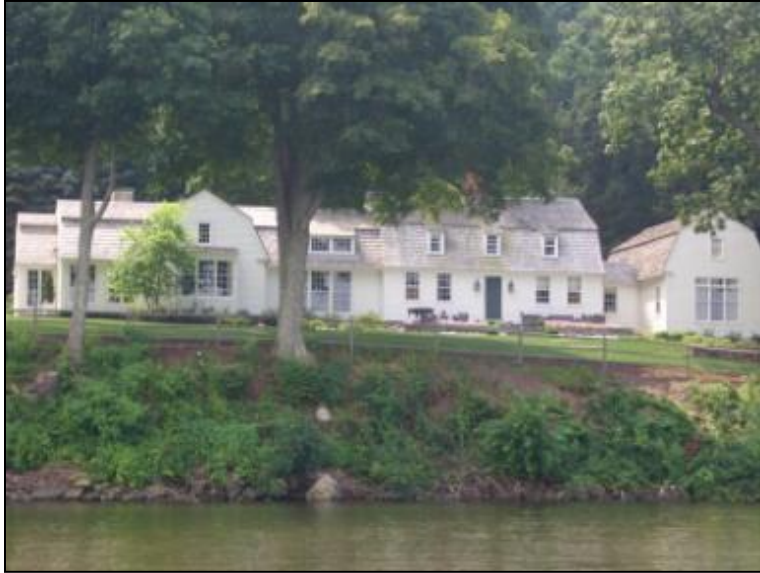
3. Existing natural buffer. Because of slope, this buffer could be enhanced by the addition of native shrubs that would help ensure that the buffer is stabilized and capable of absorbing any runoff from the adjacent lawn.

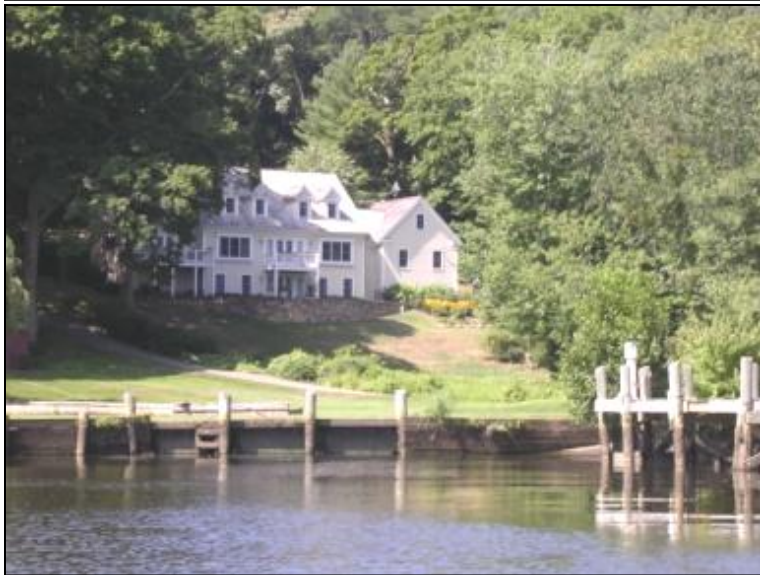
4. Long slope (gradual) increases likelihood of percolation of runoff from steeper slope adjacent to house. Modest waterfront buffer would ensure that any contaminated runoff doesn't enter the Connecticut River.

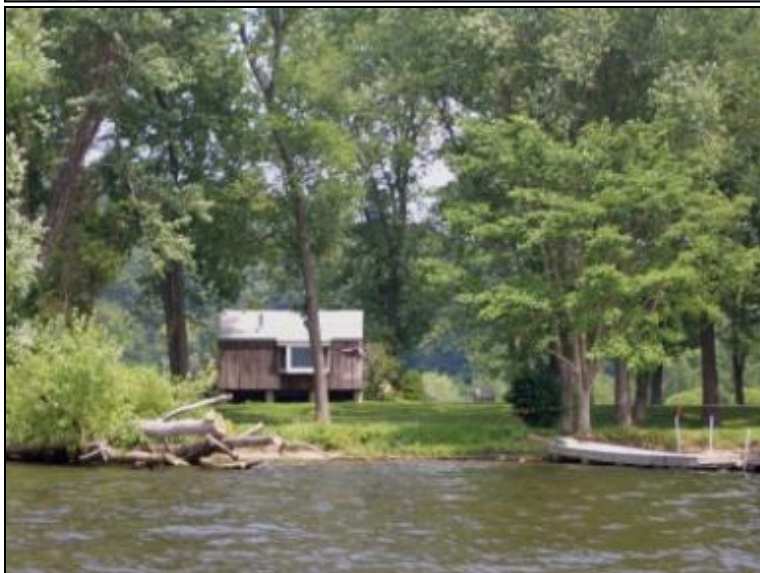
5. Partial buffer. Flat land and apparent modest use of property ; even a 10' buffer strip of un-mowed or infrequently mowed vegetation to "rough up" surface would encourage infiltration before any potential contaminants could reach the River.

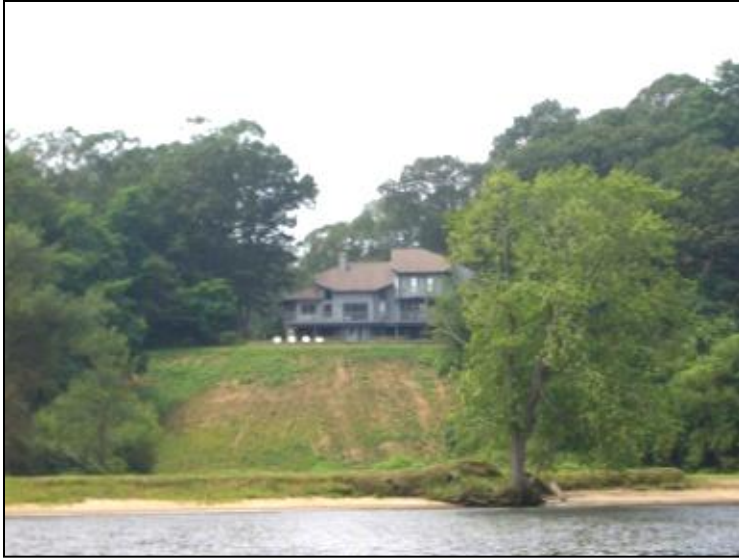
6. The addition of native vegetation to this bare slope would mitigate the potential for soil erosion and encourage infiltration and uptake of any pollutants that may come from the upslope lawn.

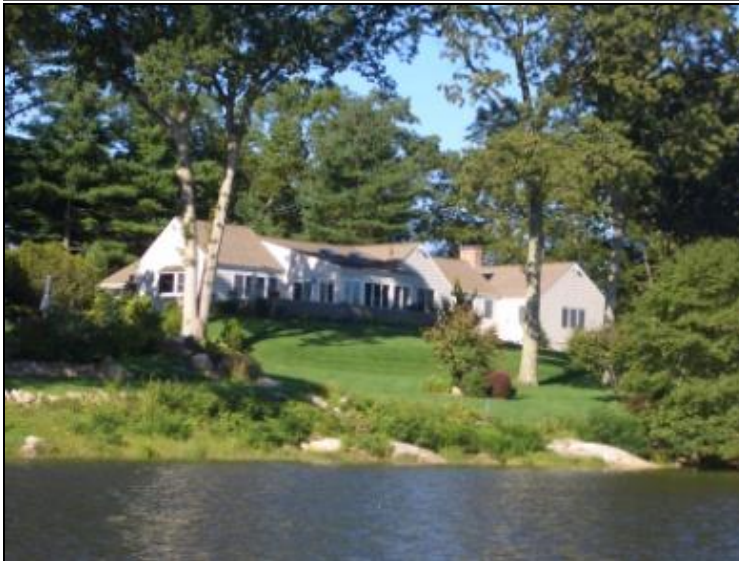
7. This partial buffer may not be up to the task of slowing and incorporating potential nutrients and chemicals from the sloping lawn behind it. Low native shrubs or ornamental grasses would enhance the buffer without sacrificing the view.

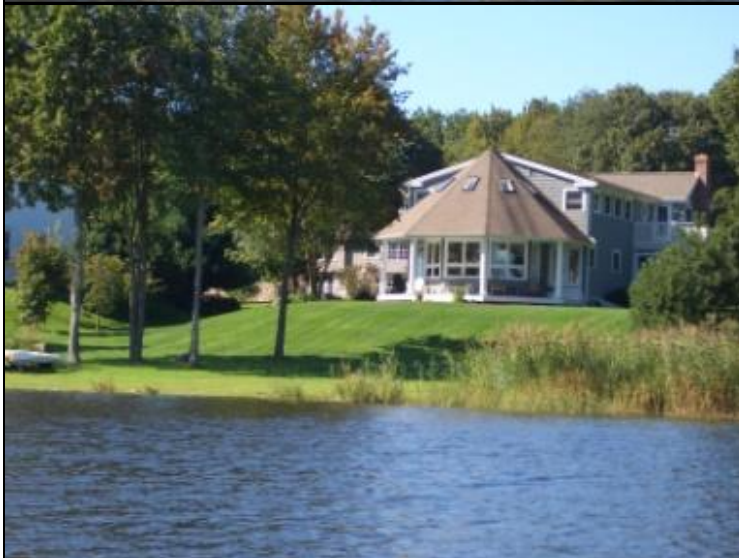
8. Even a gentle slope of grass has the potential to send excess nutrients and lawn chemicals directly into the receiving waters without the benefit of a buffer. A partial buffer exists; even a modest added area of native low shrubs would help mitigate this site.

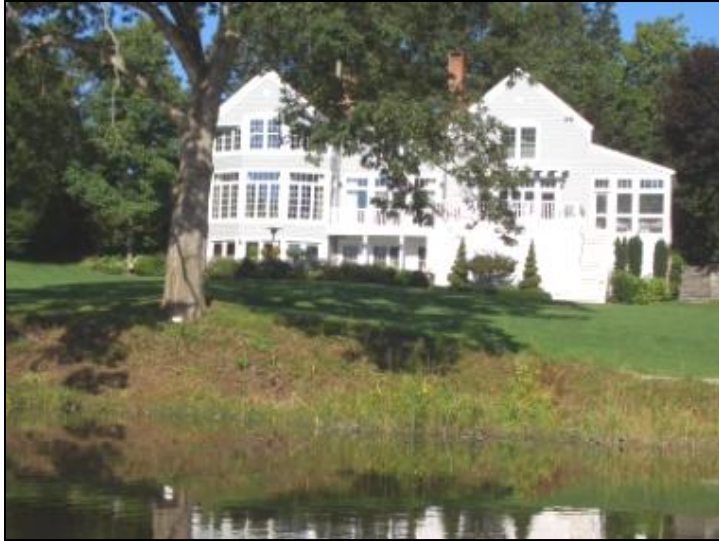
9. The existing cleared slope is a perfect place to add native vegetation that would help prevent soil erosion while also incorporating potential polluted runoff from the lawn.

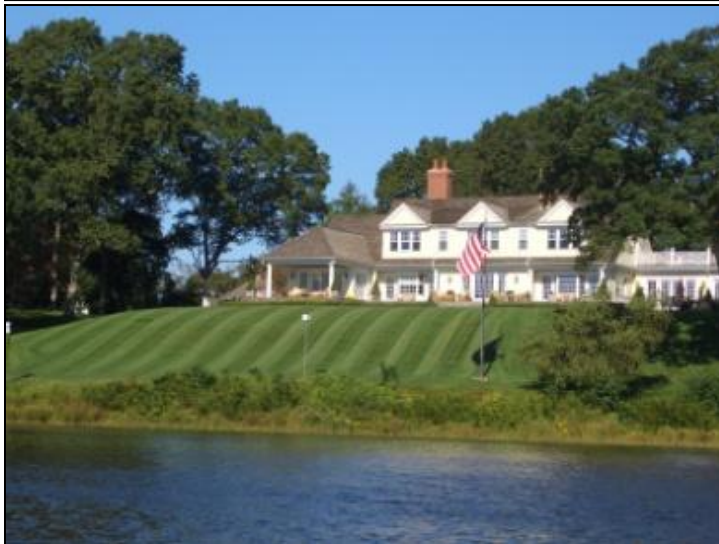
10. This riverside buffer is a welcomed addition to this residential property. It's location at the base of a steeply sloping lawn may not be sufficient to stop polluted runoff after a significant rain event and would benefit from an intermediate area where the lawn is mown infrequently to help slow runoff.

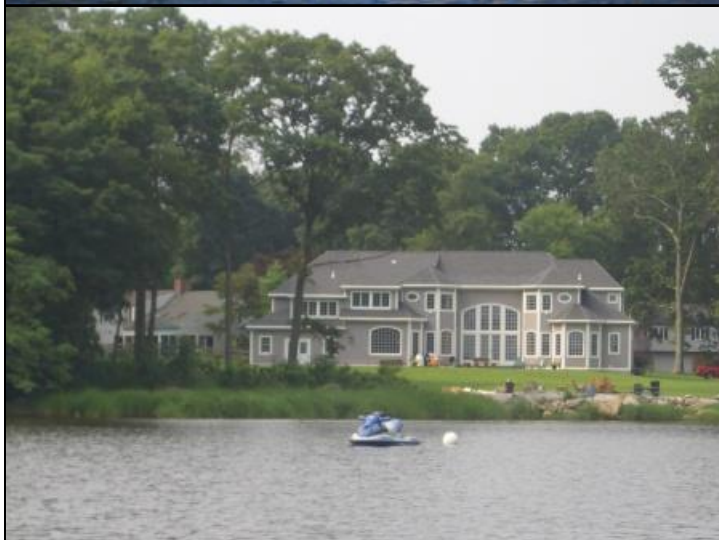
11. A low slope and partial buffer help mitigate the potential polluted runoff from this residential lawn. A modest low native-shrub border integrated with the shoreline boulders would significantly improve the filtering capability of this buffer.

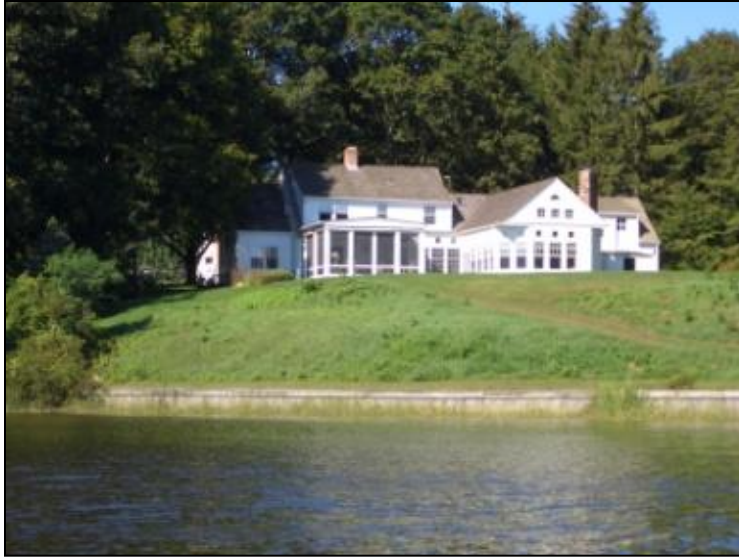
12. A steep slope and lack of direct shoreline buffer suggest that this site is at risk for generating polluted runoff. However, the “roughness” of the slope vegetation (plant height) contributes toward infiltration before any polluted water can reach the shoreline.

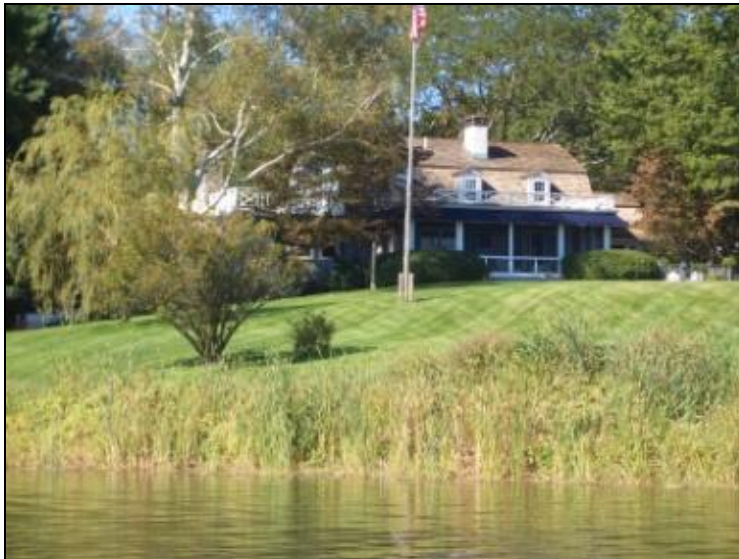
13. This shoreline buffer of natural vegetation provides an opportunity for any polluted runoff to be assimilated into the buffer plants or soil before reaching the River. It also provides valuable wildlife habitat.

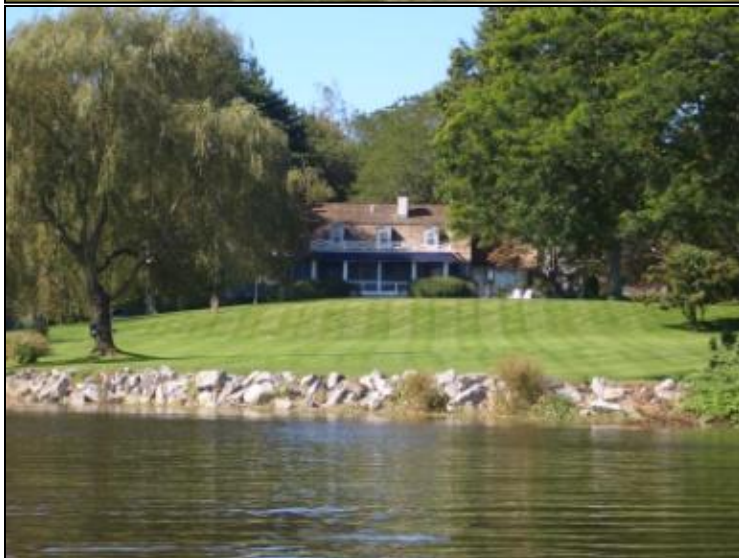
14. The length and relative flatness of this residential lawn help mitigate potential impacts from polluted runoff; however, the lack of a direct shoreline vegetated buffer increases the chances that unwanted chemicals reach the River. Low-growing native shrubs incorporated along the stone frontage would help slow down and incorporate any pollution originating from the lawn.

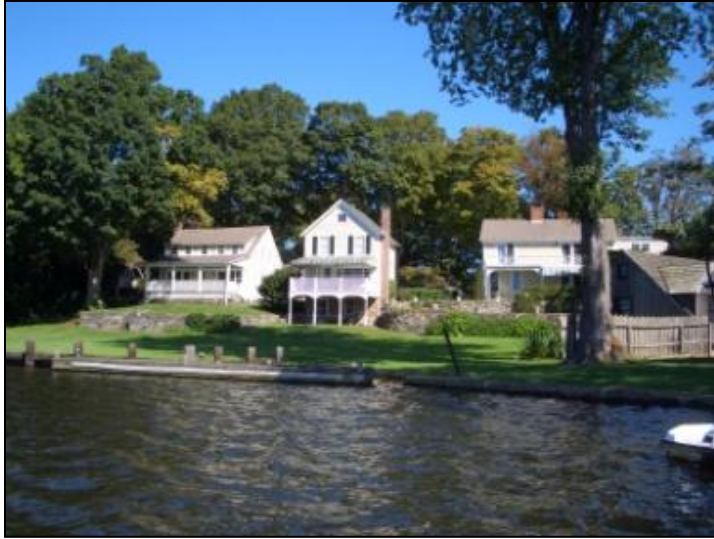
15. Multiple land owners could invest in an attractive shoreline buffer that would not impede either views or access, and could go a long way toward protecting the river from any excess pollutants coming from these lawns.

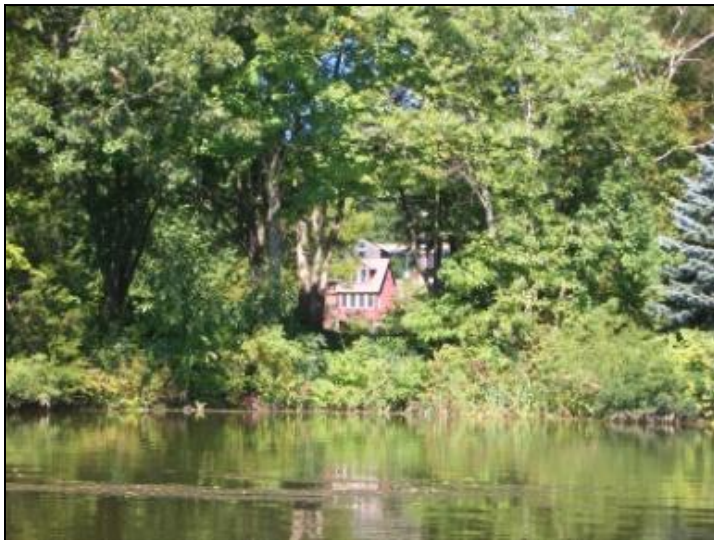
16. An entirely natural riparian buffer performs multiple functions: it filters pollutants, mitigates flood water, moderates temperature, creates an aesthetic backdrop and provides diverse wildlife habitat.

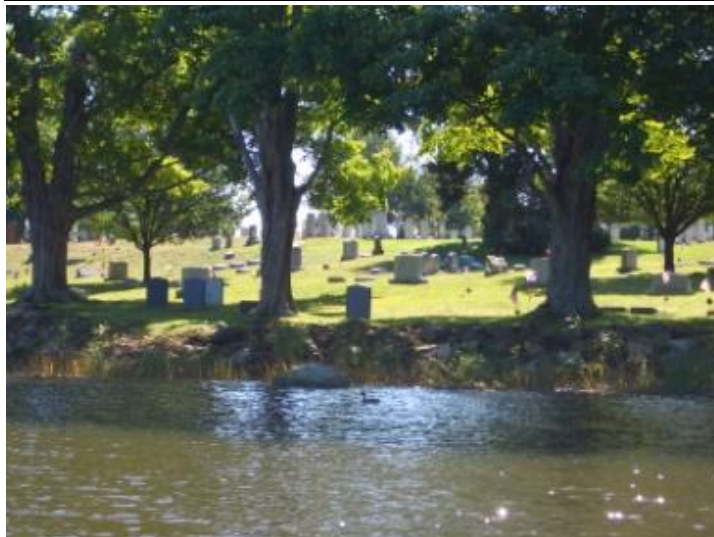
17. This municipal property could serve as a demonstration site for native riparian buffers as attractive amenities that also serve important environmental benefits.

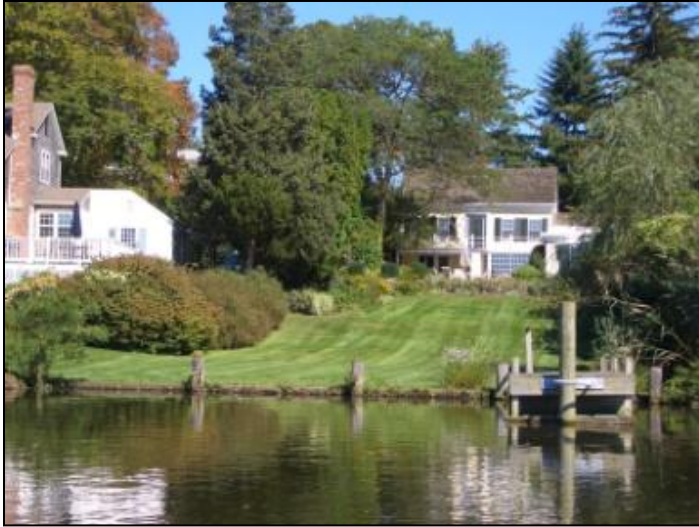
18. A modest, low native buffer along the water would not substantially detract from this visual expanse of lawn, and could play an important environmental role protecting the water quality of the Connecticut River.

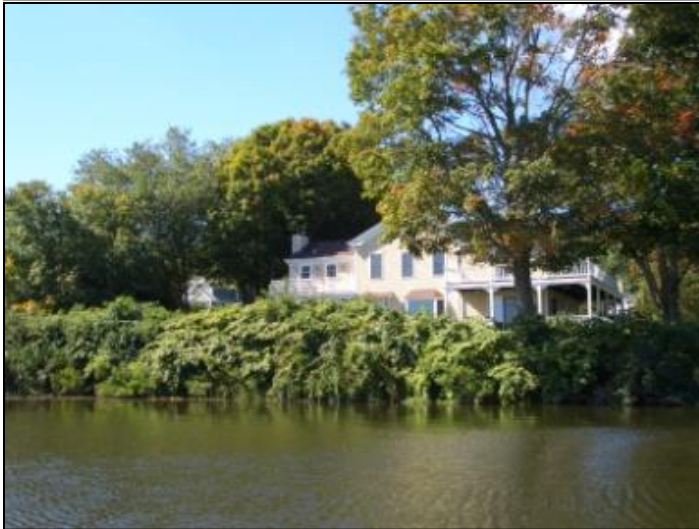
19. Even invasive plant species, such as this buffer of Japanese knotweed, can provide important environmental benefits (although may be undesirable for other reasons and best replaced by native species.)

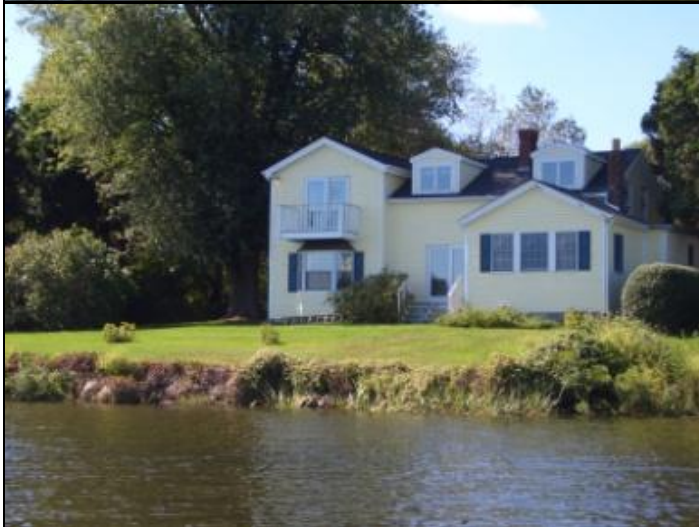
20. The low slope and close proximity to the water of this lawn make the need for a vegetated buffer even more important. Leaving even a fifteen foot buffer of infrequently mown grass (such as a fescue mix) or wildflowers would make an environmental difference without sacrificing a view or access.

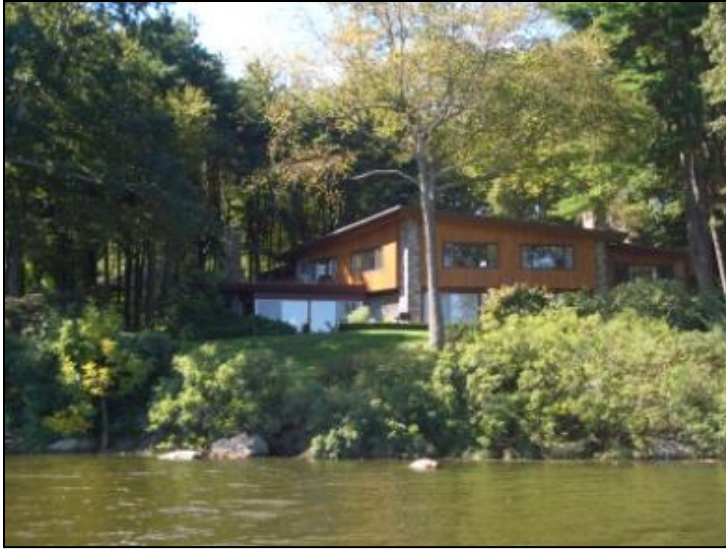
21. This natural buffer compliments the setting of this house while also performing important environmental functions. An organically managed lawn would ensure that polluted runoff does not reach the water.

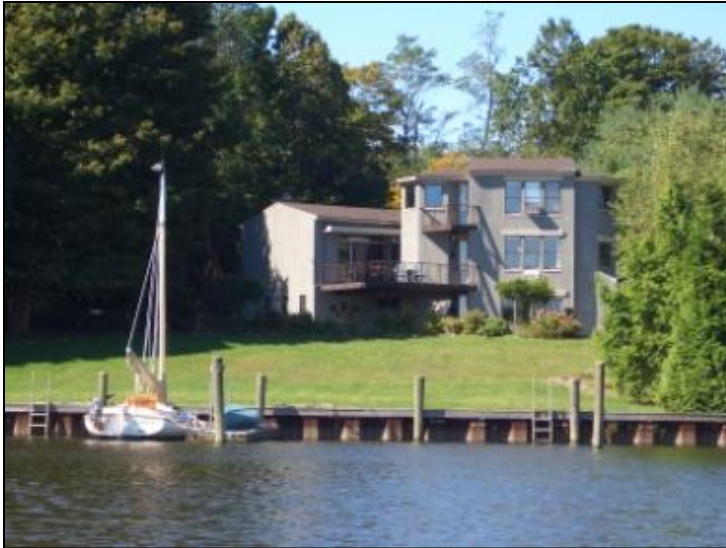
22. Although the low slope and relative length of this lawn improve the chances for any polluted water infiltration, its proximity to the water and lack of any shoreline vegetation that could slow runoff down or take it up make this property a good candidate for a buffer.

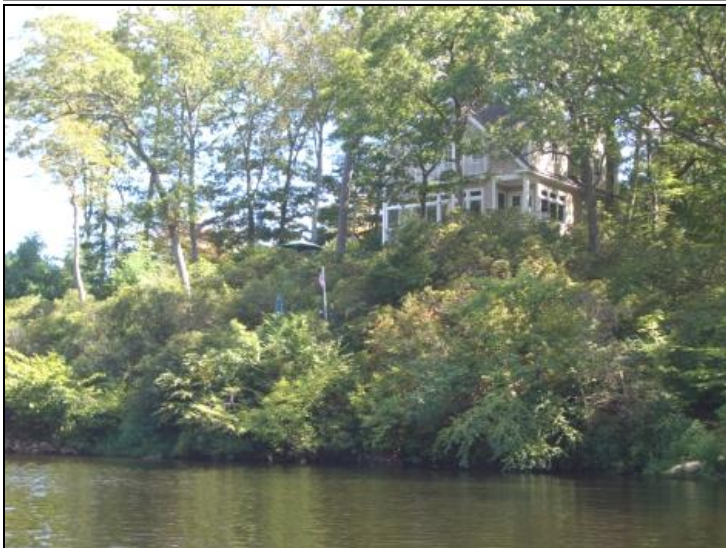
23. A poster child for riparian buffers! This property demonstrates the potential for maintaining a wooded shoreline buffer and a stellar view both from and to the water. A healthy riparian buffer includes stratification of trees, shrubs and herbaceous plants, and provides wildlife habitat, organic nutrients to the water, and an attractive and reasonably low maintenance lawn alternative.

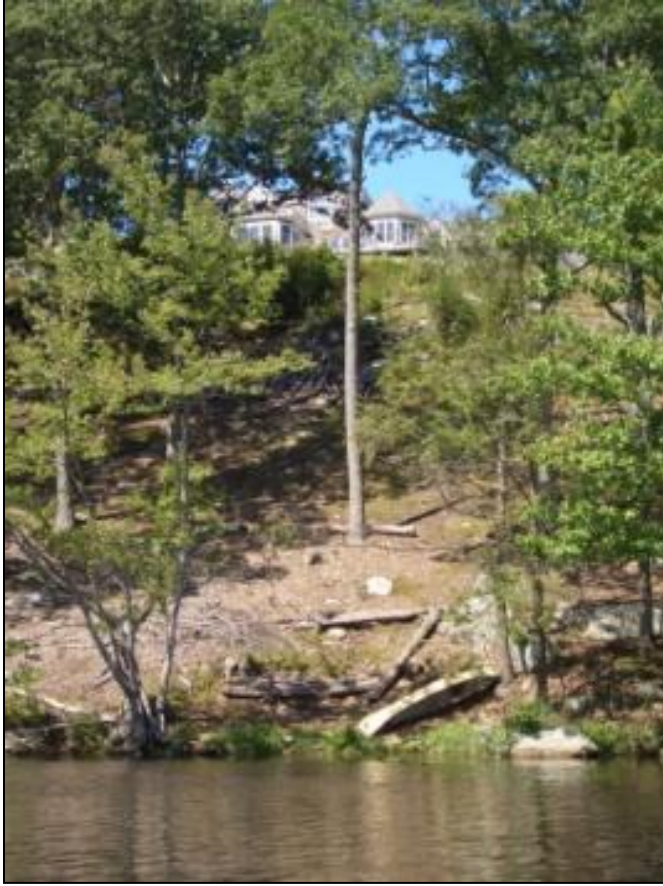
24. Although wooded, this steep-sloped property may lack enough understory vegetation – shrubs and herbaceous plants – to prevent overland flow of potentially polluted water from the house/yard above, especially from late summer thunderstorms. A modest buffer at the top (or bottom) of the slope would help ensure protection.

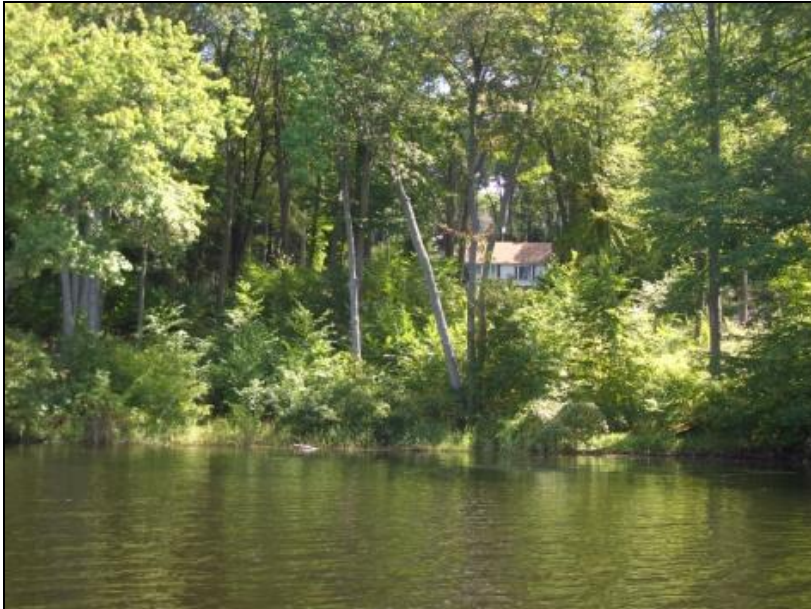
25. This residence is nestled within a fully functioning and healthy shoreline riparian buffer that provides abundant habitat for wildlife, organic nutrients to the river system, and shoreline shading for near shore aquatic organisms.

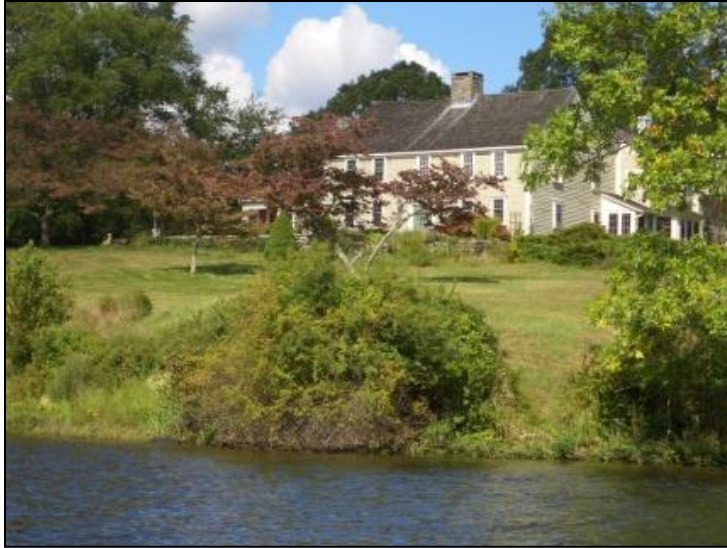
26. Although there is a modest shoreline buffer along this property, a small opening to the waterfront could easily transport excess fertilizer and chemicals from the adjacent, sloping lawn. Water bars could be used to redirect overland flow of potentially polluted water away from the water and into the bordering riparian vegetation.

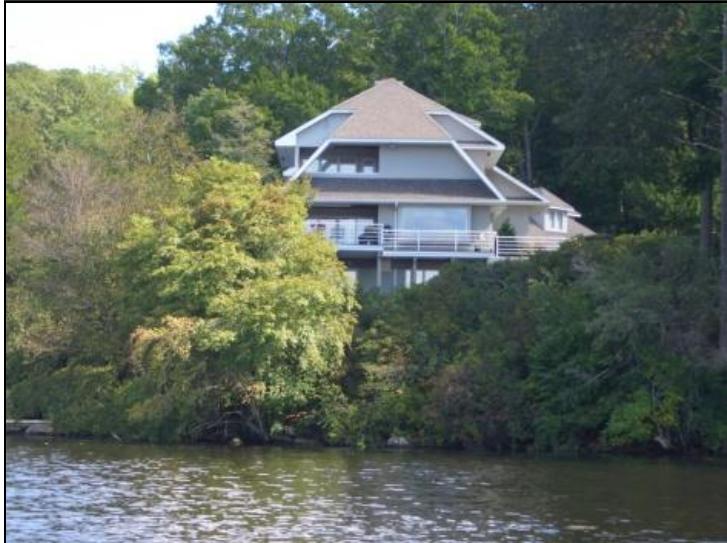
27. Intact riparian vegetation can complement and soften shoreline buildings, in addition to providing important water quality benefits.

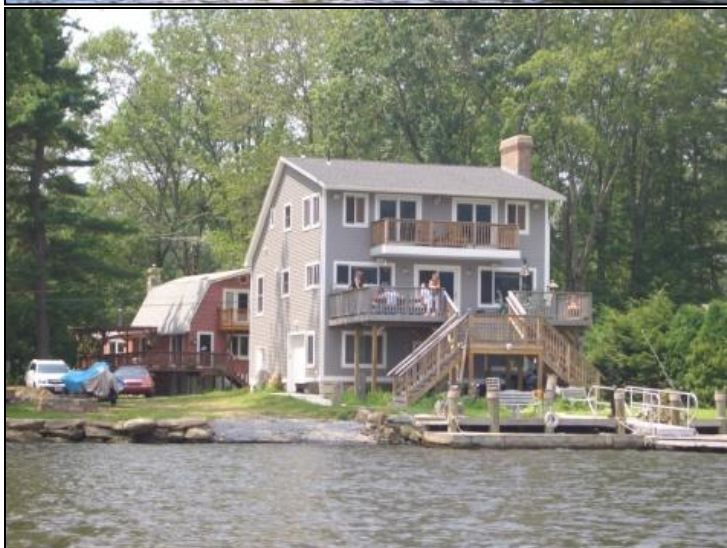
28. A home this close to the water has little space to buffer land use from the river. Just the same, even a row of ornamental grasses planted along the water's edge would help moderate potential water pollution inputs, and would provide low maintenance landscaping.

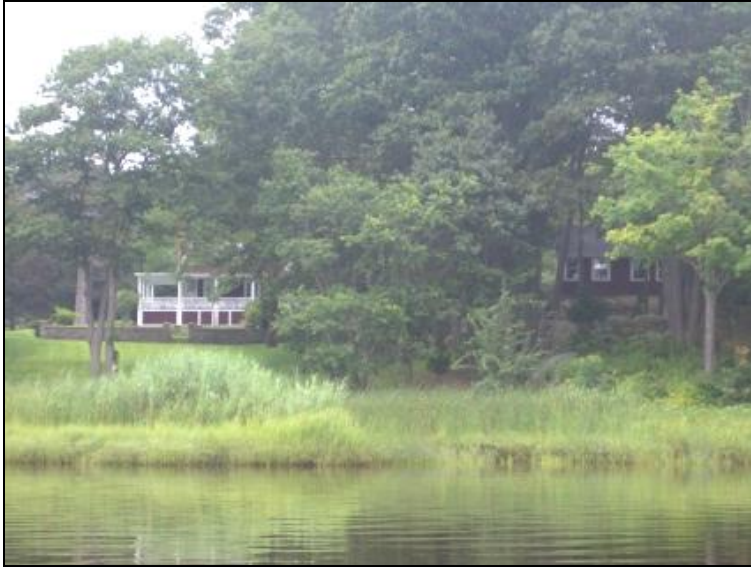
29. Two shoreline residences demonstrate different buffer treatments: the house on the right has allowed natural vegetation to dominate, while the house on the left has chosen to maintain a lawn. Both properties have the benefit of a modest shoreline buffer. Perhaps excess nutrients from the lawn have helped fuel the invasive *Phragmites* reed grass in front of the house on the left?

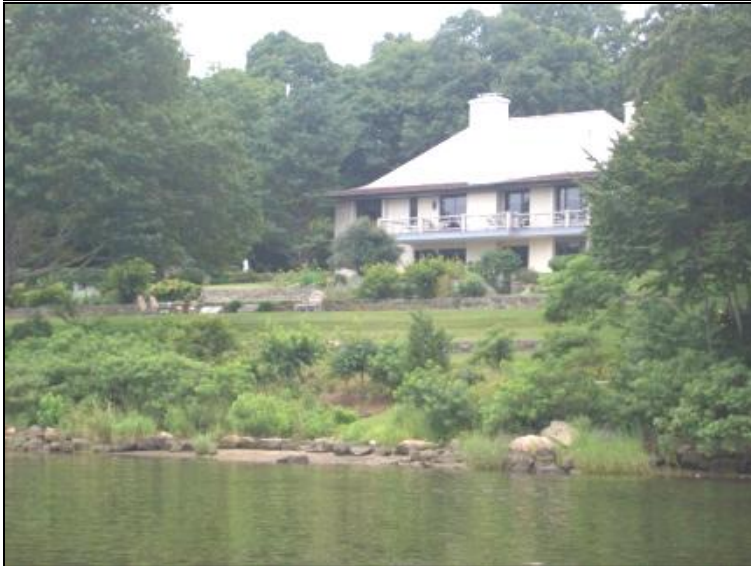
30. This shoreline buffer is diverse and occupies the modest slope in front of this residence's lawn, creating an important tool to accumulate and assimilate any nutrients or chemicals leaving the lawn area.

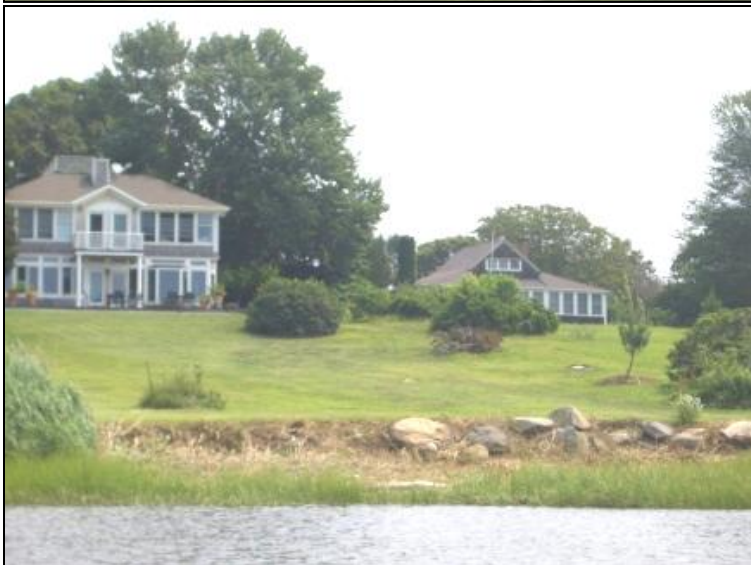
31. Although this is a long and relatively gentle sloping lawn, the newly cut shoreline buffer reduces the possibility of this area providing the important buffer services of healthy and diverse natural vegetation.

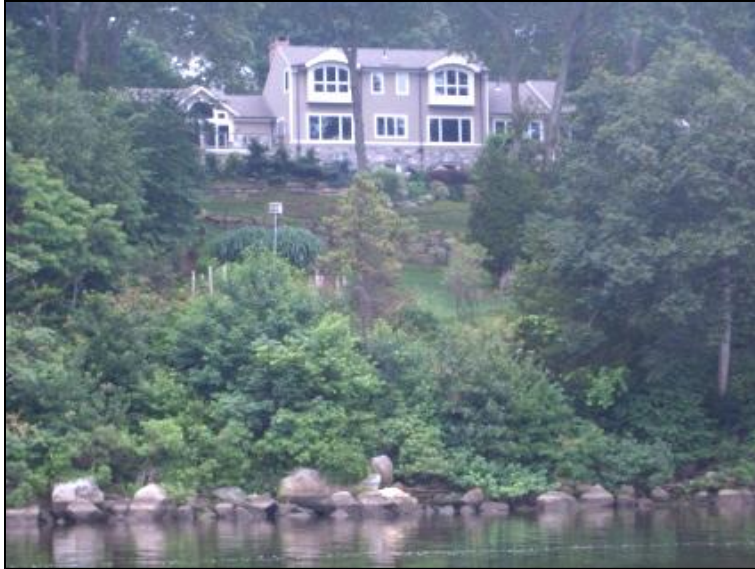
32. The steepness of this slope places a lot of pressure on the toe of slope vegetation to moderate any overland flow of potentially polluted water, particularly after a significant storm event. Even so, the remaining buffer vegetation appears diverse and full, increasing its effectiveness.

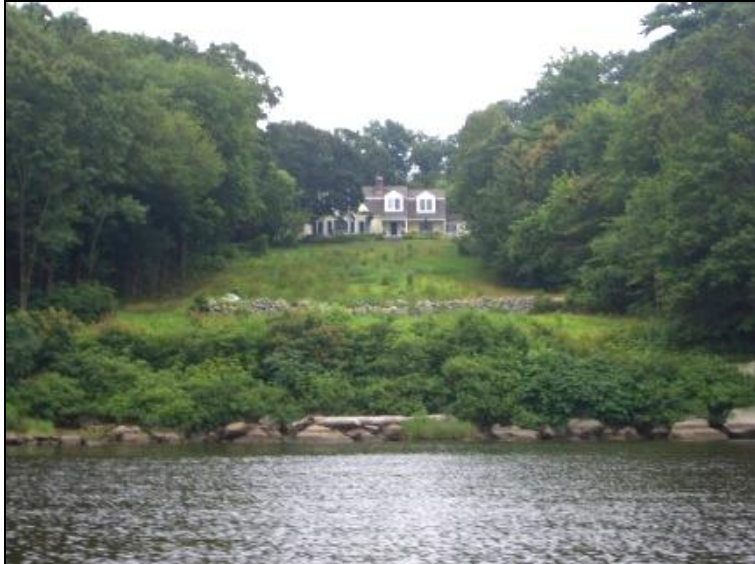
33. The end of this long, gentle slope is finished with a dense vegetated buffer that likely minimizes any potential for polluted water reaching the river.

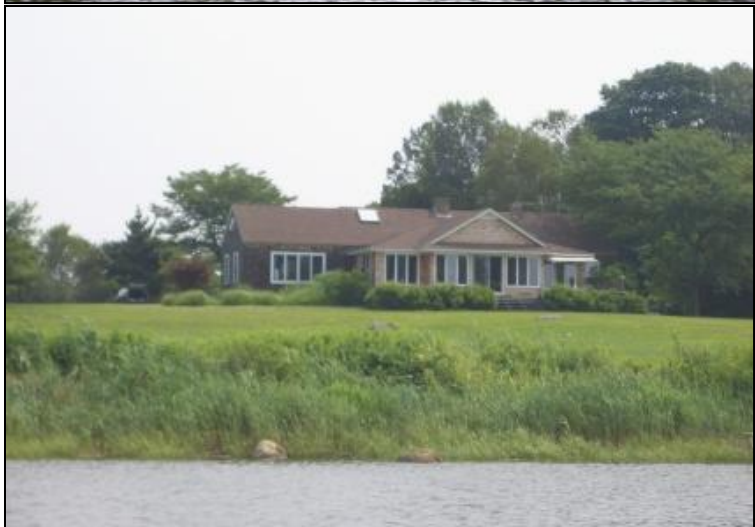
34. Even though there is a modest shoreline buffer on this property, the slope of this lawn increases the potential for any polluted runoff to make it into the River.
